Replacement of a single anterior tooth

Surgical procedure and three-year results

Author_Dr Peter Randelzhofer, Germany

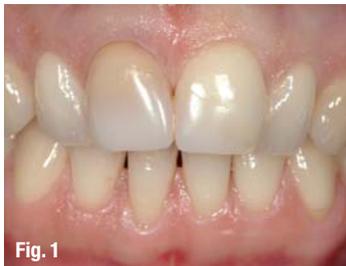
Fig. 1 The patient had a high smile line, and tooth #11 was discoloured and had a poor prognosis. The gingiva was thick and the interdental papillae had a high-scalloped appearance.

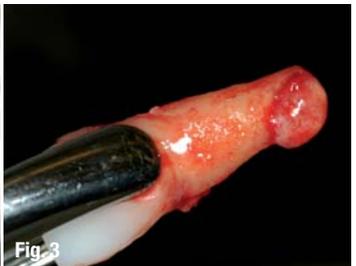
Fig. 3 Careful extraction of tooth #11.

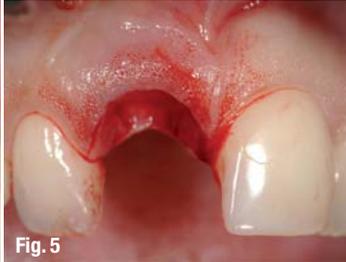
Fig. 5 Intact coronal buccal bone plate: Note the thin interdental papillae. The remaining scar tissue of the former apex resection is clearly visible.

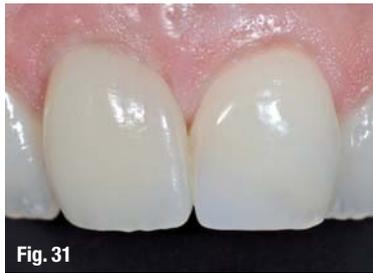
Fig. 31

Fig. 31_Stable soft tissue showing no resorption at the implant-crown interface or gingival sulcus.

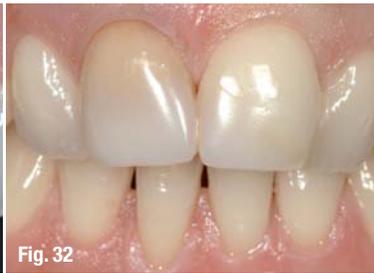
Fig. 32

Fig. 32_Initial situation before extraction.
