Reconstruction of a horizontal ridge defect using the bone lamina technique

Author_ Dr Arndt Happe, Germany

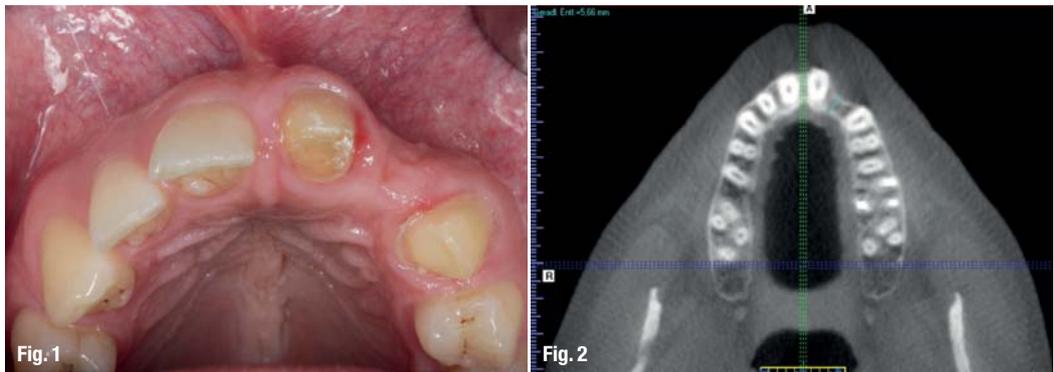
Fig. 1 Localised horizontal ridge defect. The treatment plan was to place a single implant to replace the lateral incisor.

Fig. 2 A CBCT scan of the defect. The residual ridge width was 5.6 mm.

In the case presented, the treatment plan was to place a single implant in the aesthetically demanding anterior maxillary region in the place of the left lateral incisor. A moderate horizontal ridge defect was present and the residual bone width was 5.6 mm. A staged approach

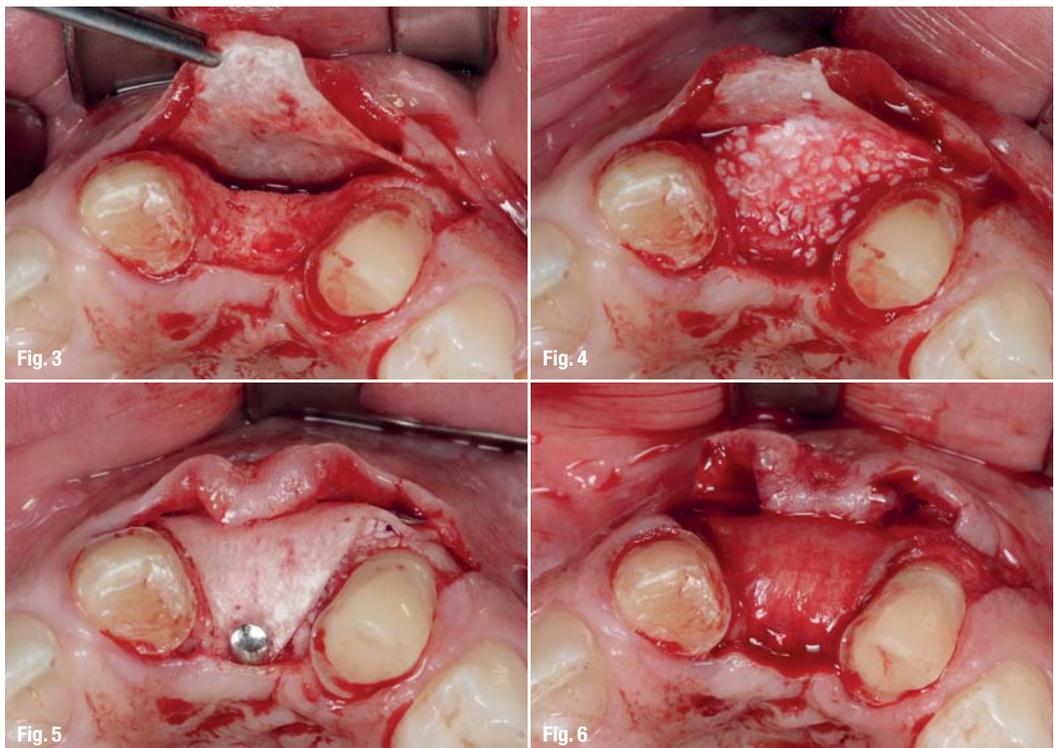
Fig. 3 Once a full thickness flap had been reflected, the buccal plate was reconstructed using OsteoBiol Soft Cortical Lamina. The lamina was secured using titanium pins.

Fig. 4 The defect was filled with OsteoBiol mp3.

Fig. 5 The lamina was shaped such that it could be folded over the coronal aspect of the filler material.

A titanium pin was used to secure the lamina here too.

Fig. 6 The lamina itself was covered with a collagen membrane to allow for rapid soft-tissue integration.

employing a guided bone regeneration technique with a porcine partially demineralised cortical lamina (OsteoBiol Soft Cortical Lamina, TecnoSS Dental) was chosen. A porcine bone substitute (OsteoBiol mp3, TecnoSS Dental) was used as a filler material.

After the augmentation procedure, the lamina was covered with a collagen membrane to allow for rapid soft-tissue integration. The augmentation surgery was completed with meticulous flap closure using microsurgical techniques.

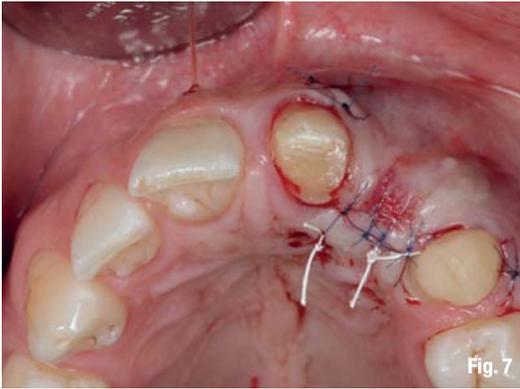
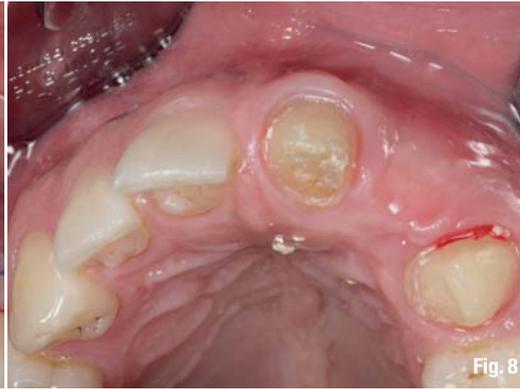
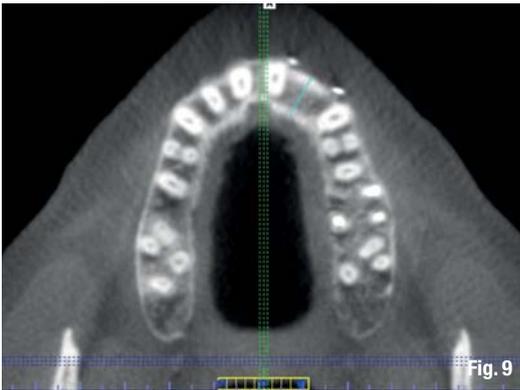
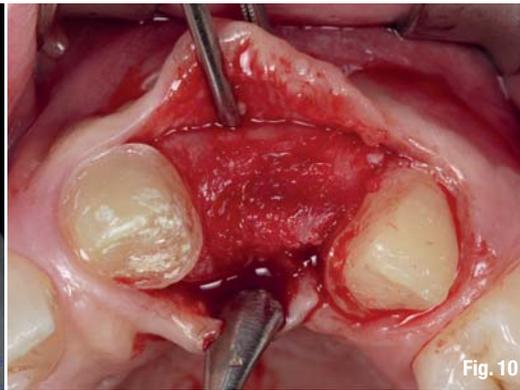
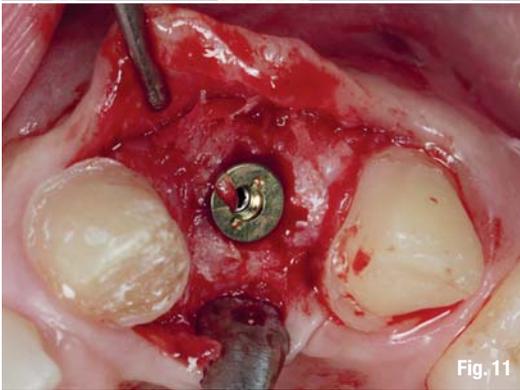
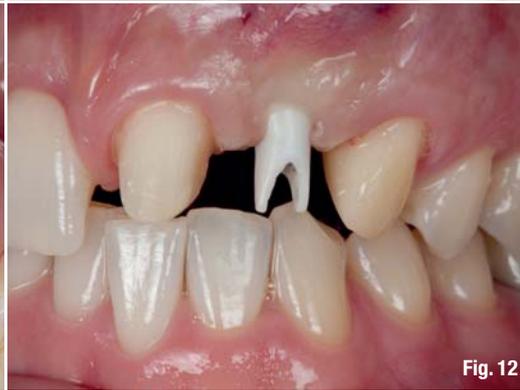
Fig. 7_ Meticulous, tension-free soft-tissue closure is crucial for successful regeneration.
Fig. 8_ The clinical situation after six months of healing.
Fig. 9_ A CBCT scan showing the regenerated area. The ridge width was increased to 10.3 mm. A new cortical plate and cancellous compartment are visible.
Fig. 10_ Upon reflection of a full thickness flap, the regenerated tissue is visible. The tissue has a good blood supply and remnants of the lamina are present.
Fig. 11_ It was possible to place an implant of 3.8 mm in diameter in the correct 3-D position as planned.
Fig. 12_ The regenerated ridge before restorative treatment.

After a healing period of six months, an implant of 3.8 mm in diameter and 11 mm in length was placed according to the restorative planning.

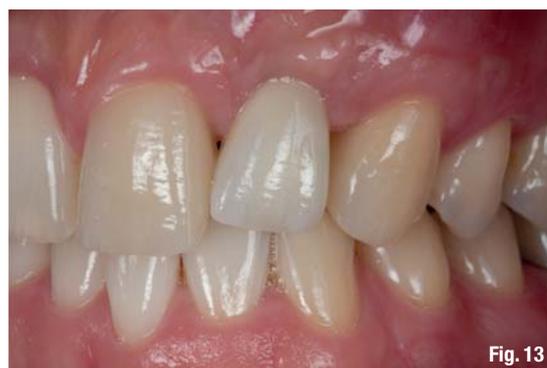
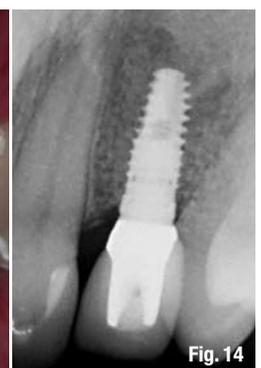
Fig. 13_ The final situation six months after seating the all-ceramic restoration.
Fig. 14_ A periapical radiograph six months after restorative treatment.

Finally, an all-ceramic crown was seated on the zirconia abutment.

The images of the final result demonstrate clearly that an aesthetically pleasing outcome was achieved by employing the bone augmentation technique described.
