Laser-assisted re-establishment of Canine Guidance: Esthetic and Functional Reconstruction of Worn Canines

author_Carlos de Paula Eduardo¹, Marina Stella Bello-Silva², Karen Müller Ramalho³, Roberta Marques da Graça Lopes⁴, Patricia Moreira de Freitas⁵, Brazil

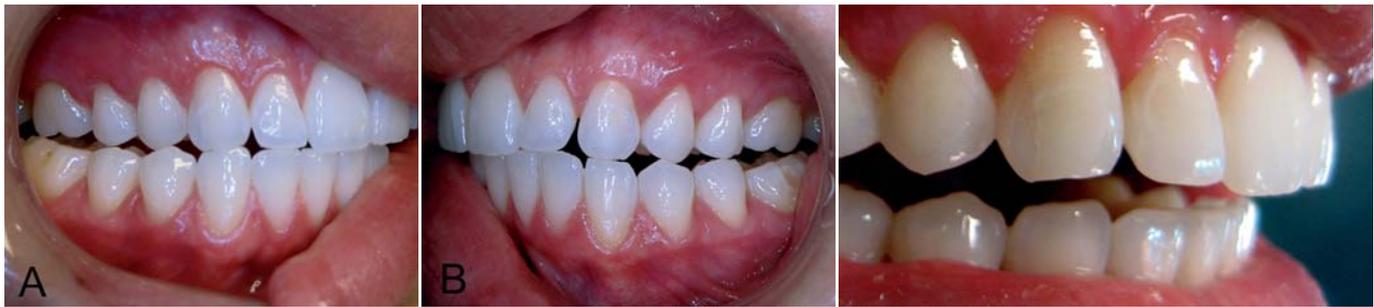
Fig. 1_Initial clinical status.

A Right side view: Loss of canine guidance and presence of contacts on lateral incisors, pre-molars and disto-buccal cusp of the first molar.

B Left side view: Loss of canine guidance and occlusal contacts on lateral incisors and pre-molars.

A diastema between the upper right canine and lateral incisor caused by the occlusal interference can be noticed.

our clinic presenting wear facets on the edges of the upper and lower canines (Fig. 1). The patient reported muscular fatigue in the morning and clenching during the day, and these symptoms were attributed to the patient's parafunctional bruxing habit. The canine guidance was no longer present, and the wear pattern indicated that jaw lateral excursive movements were predominant during bruxism episodes. This fact could also be attested by the presence of a diastema between the upper right canine and lateral incisive (Fig. 1B), as the patient reported that it first appeared after bruxism habit initiated. Since the canine edge was lost due to tooth wear, the canine guidance was substituted by group function guidance, and an intense contact between upper and lower lateral incisors during lateral excursive movements may have caused tooth movement and diastema appearance. The intense strength exerted on the canines during clenching and grinding resulted in the appearance of cracks (Fig. 2), as well as in the loss of tooth anatomy.

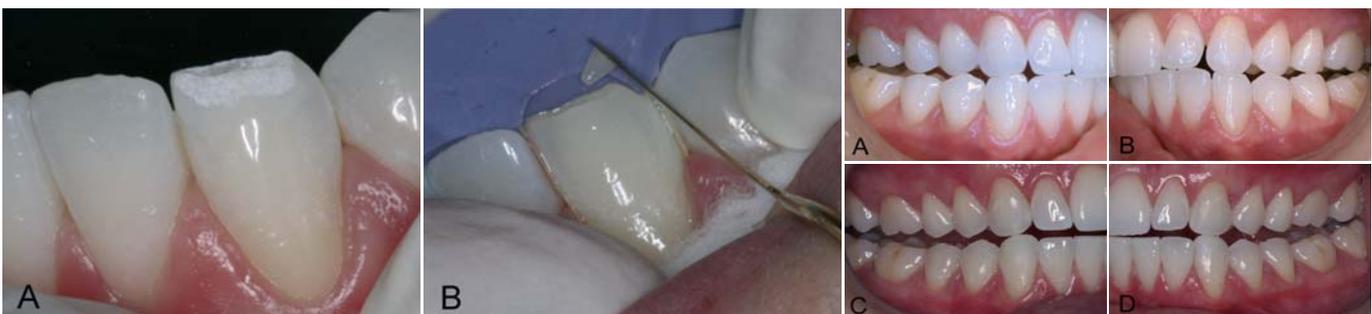
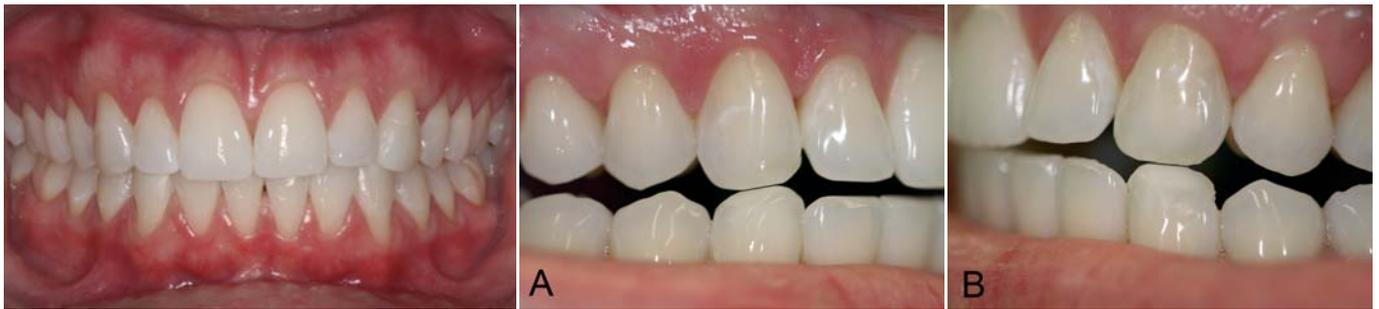
Fig. 9A_ Right lateral movement before restoration. Contacts on lateral incisors, premolars and molars can be noticed.

Fig. 9B_ Left lateral movement before restoration, with contact on lateral incisors and premolars.

Fig. 9C_ After the reconstruction of right canine guidance, an adequate space was created between antagonist incisors, premolars and molars during lateral movement.

Fig. 9D_ Space between antagonist incisors, premolars and molars during left lateral movement after the reconstruction of canine guidance.

The resin excesses of the cervical area were removed with a #12 blade. The occlusal contacts were adjusted, and the canine guidance was carefully re-established. Finishing and polishing procedures were conducted with polishing discs, interproximal abrasive strips and polishing pastes (Sof-Lex Pop-On, 3M ESPE, St. Paul, MN, USA; Enamelize, Cosmedent, Chicago, IL, USA). Right after restoration conclusion, the patient was given hard acrylic occlusal guard to protect restoration from further wear and to manage bruxing habit. Canines' reconstruction using direct resin restoration enabled the achievement of both harmonious esthetics and adequate function (Figs. 9 and 10).
